# ***A-1 HOME INSPECTION***

***23395 MAVERICK INSPECTION, MO.***

***This report was prepared for John Q  
By A-1 Home Inspection***

## **Confidential Inspection Report**

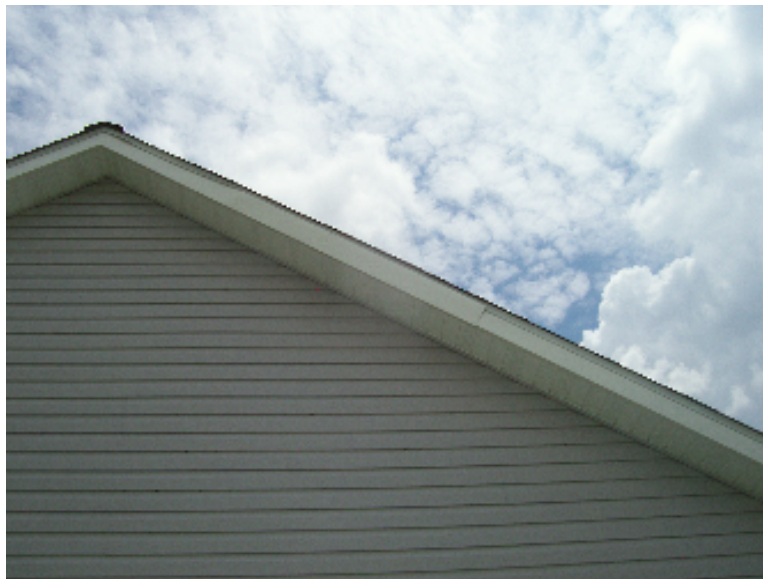
Loose soffit west side.

***LOOSE SOFFIT WEST.***

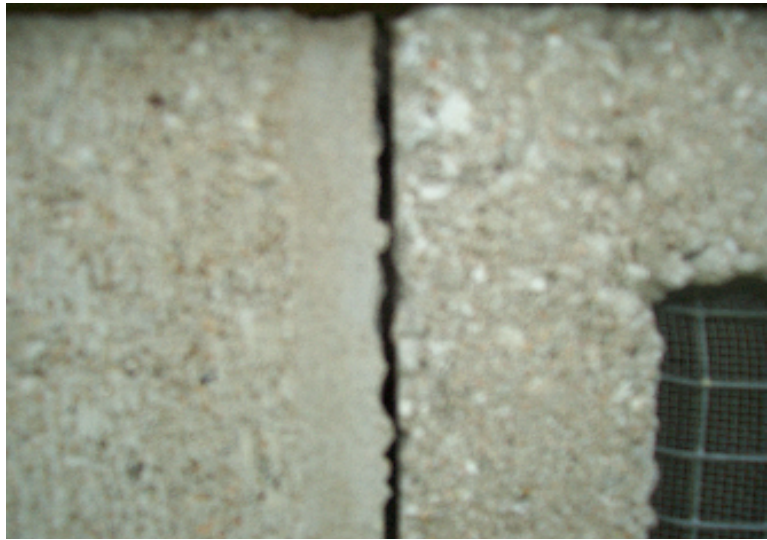
Vapor barrier has been removed and is holding water in crawlspace: Remove old and install new.  
Fungal growth on a few joist and sub flooring at the back section of the crawlspace.  
Foundation mortar cracks west with no signs of displacement: Future observation.

***FOUNDATION MORTAR CRACK.***

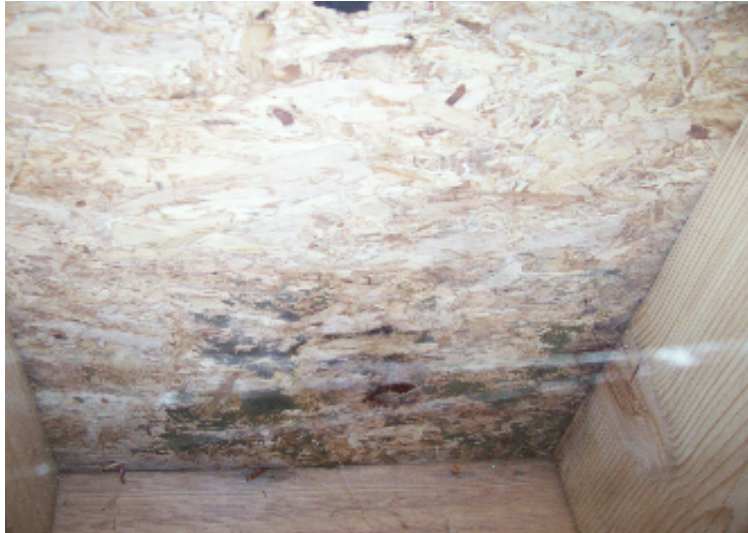
**STRUCTURE:** Sound and in working condition, no major defections observed, remove old vapor barrier in the crawlspace and install new, fungus present rear crawlspace on joist and sub flooring, some mortar foundation cracks with no signs of displacement.

***FUNGUS SUB FLOORING REAR.***
